**FALLUJA WASTE WATER  
TREATMENT SYSTEM  
FALLUJA, IRAQ**

**SIGIR PA-08-144  
SIGIR PA-08-145  
SIGIR PA-08-146  
SIGIR PA-08-147  
SIGIR PA-08-148**

**OCTOBER 27, 2008**

## Falluja Waste Water Treatment System

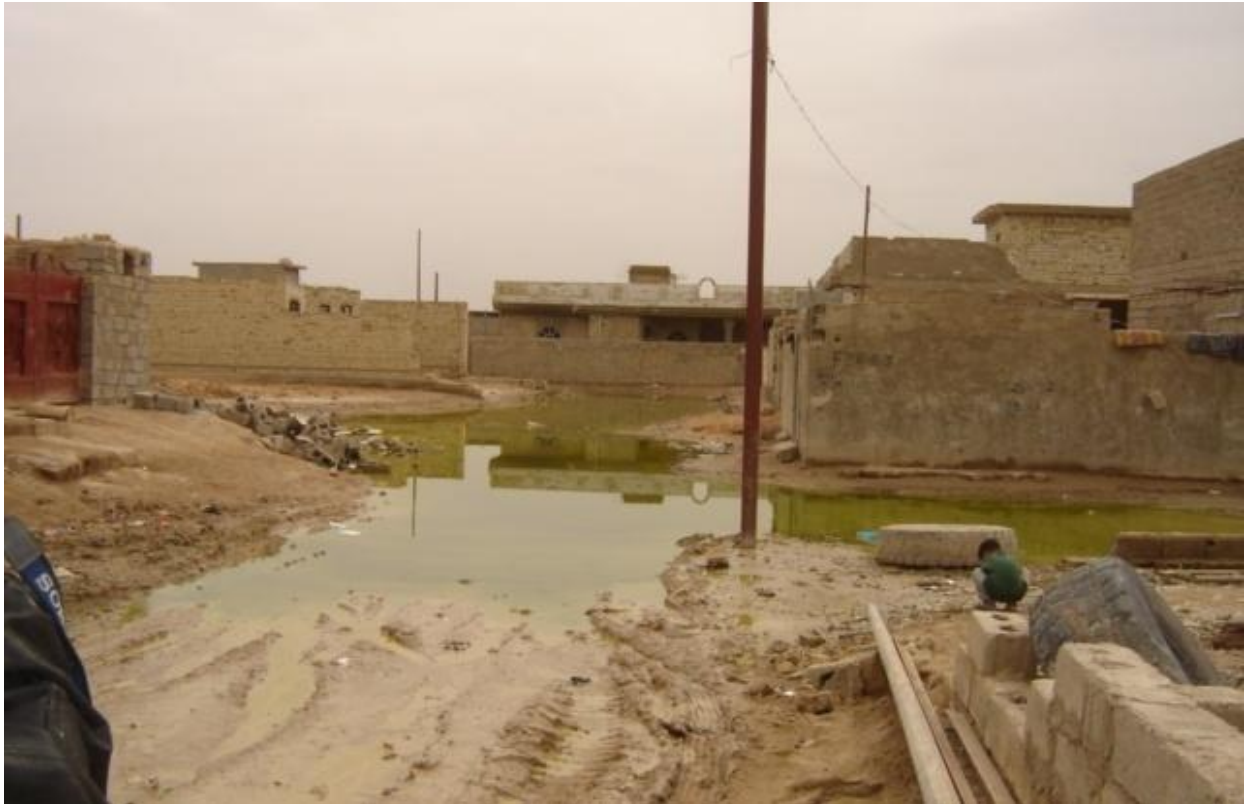
River contaminates the river water that is used by the public for several purposes, including a source of potable drinking water. In addition, sewer water runs down through the center of the city streets (Site Photo 1). Since children often play in the streets and sewer water, serious health issues, particularly among the young, exist.

**Site Photo 1. Sewage flowing throughout Falluja city streets**

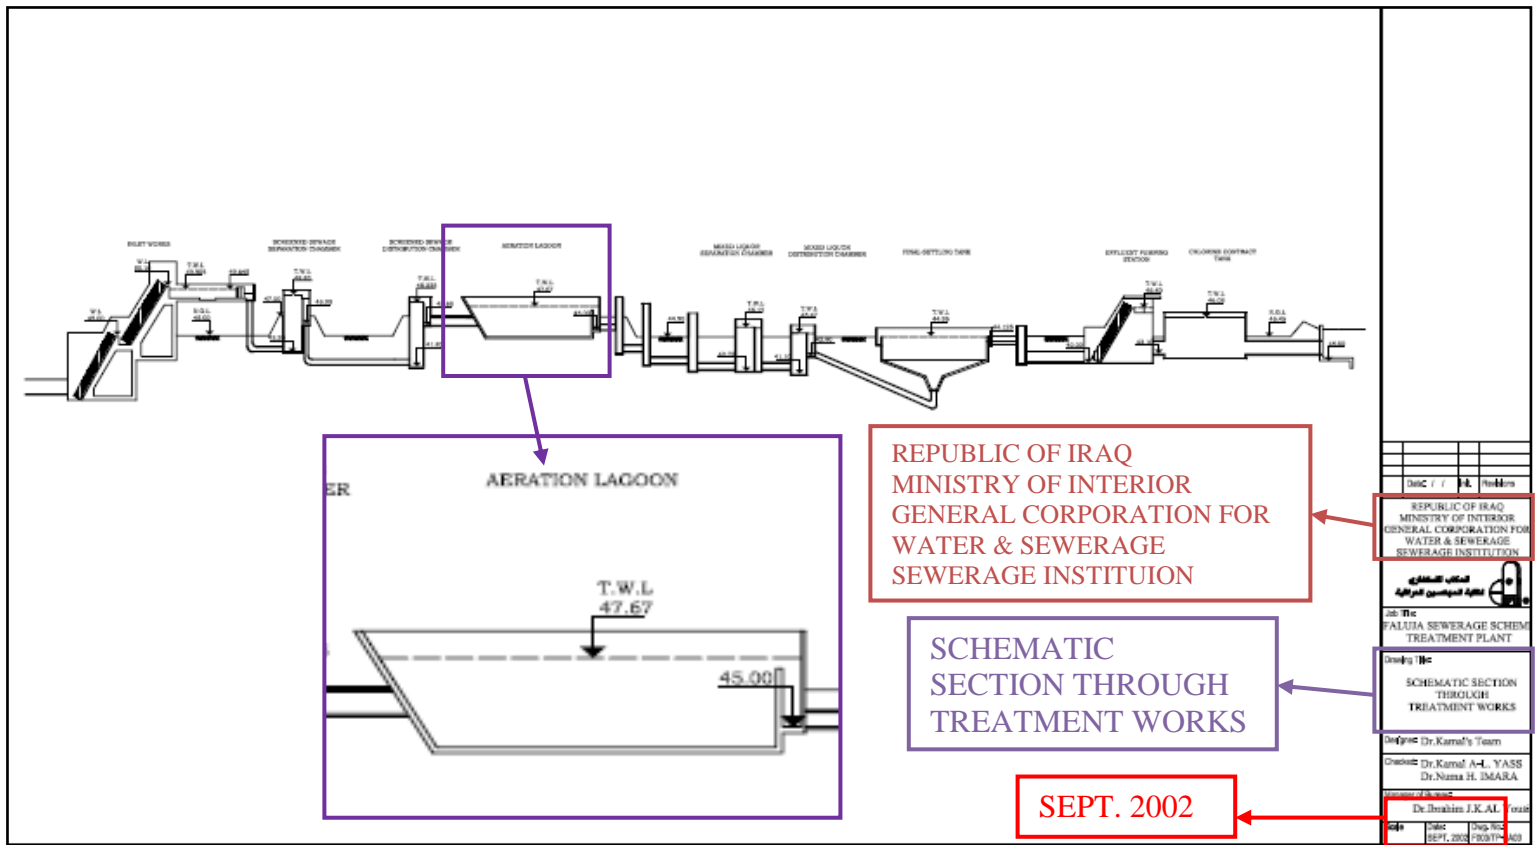
Figure 2. Ghadak's original schematic layout of the WWTP, which was designed to use a lagoon system (Figure courtesy of the USACE)

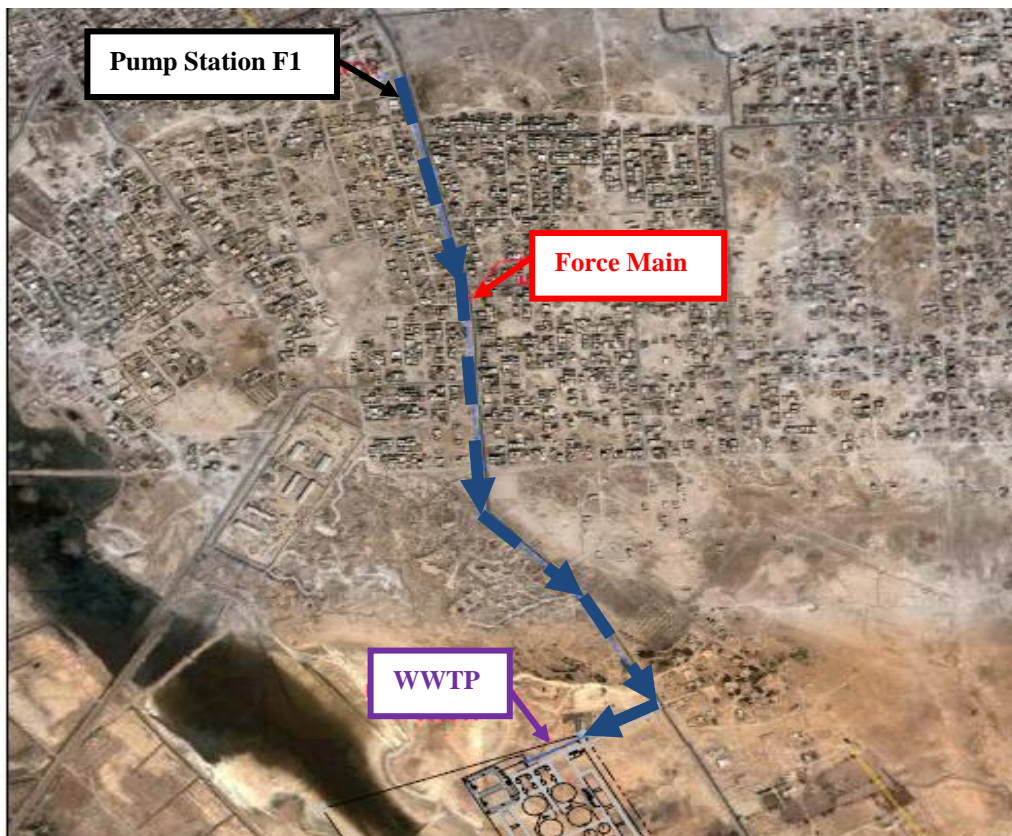
**Figure 4. Location of Force Main (between the Pump Station F1 and WWTP)  
(Figure courtesy of the USACE)**

According to Camp Falluja Resident Office documentation, this project was constructed without delay and has been fully flow tested and hydrostatically tested. In addition, the contractor submitted his close-out package, including as-built drawings, test results, hydro-test results, equipment listings, and spare parts. The Camp Falluja Resident Office has identified this contractor as “one of the best we have experienced here in Fallujah to date.”

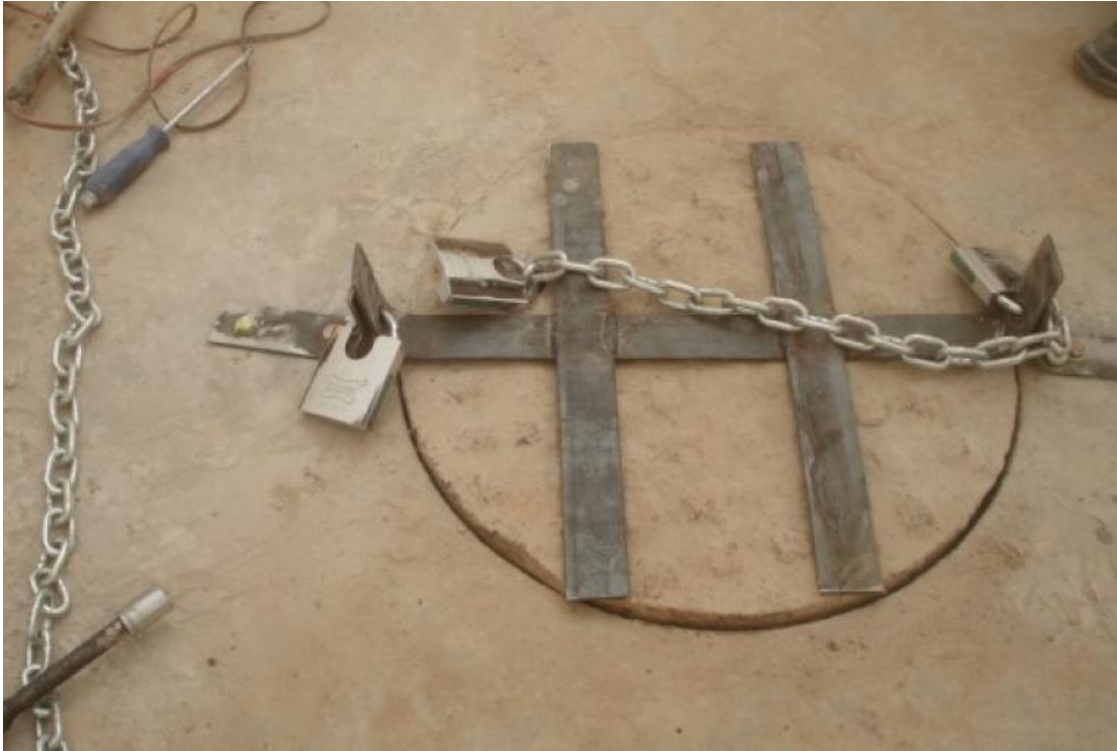
This contractor has notified the USACE that “he will not allow beneficial occupancy until he has received the outstanding balance due to him through DFI.” All manholes and valve boxes are now locked down, preventing its use until such time as full and final payment is made (Site Photos 3-5).

**Site Photo 3. Force Main manhole locked by contractor over non-payment of DFI contract  
(Photo courtesy of the USACE)**

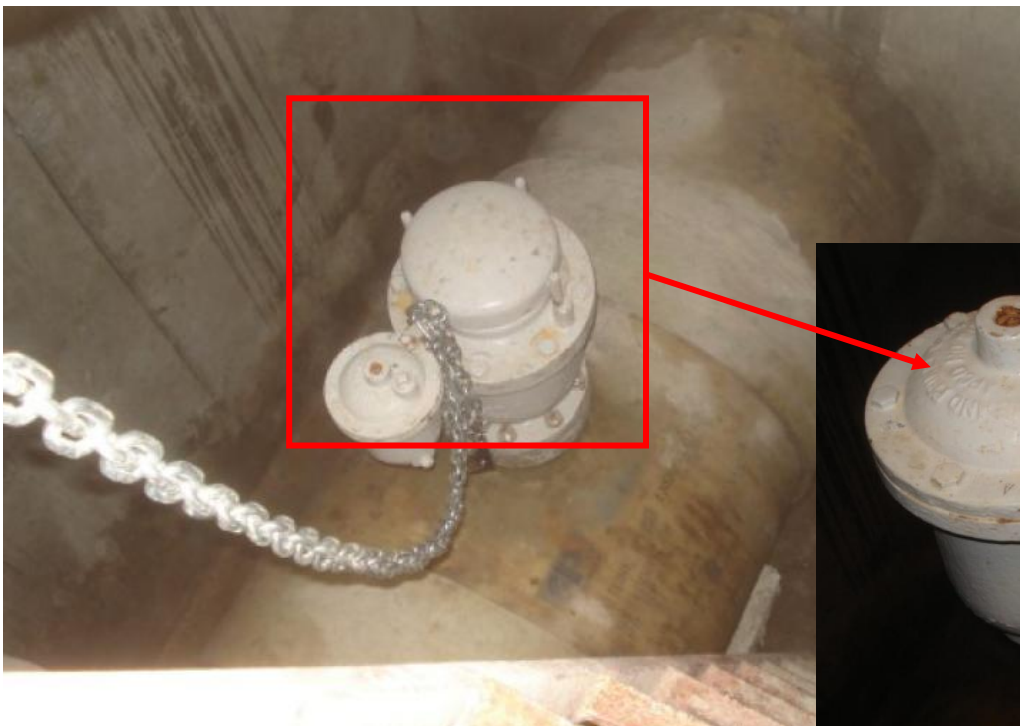
**Site Photo 4. Force Main valve box locked by contractor  
(Photos courtesy of the USACE)**

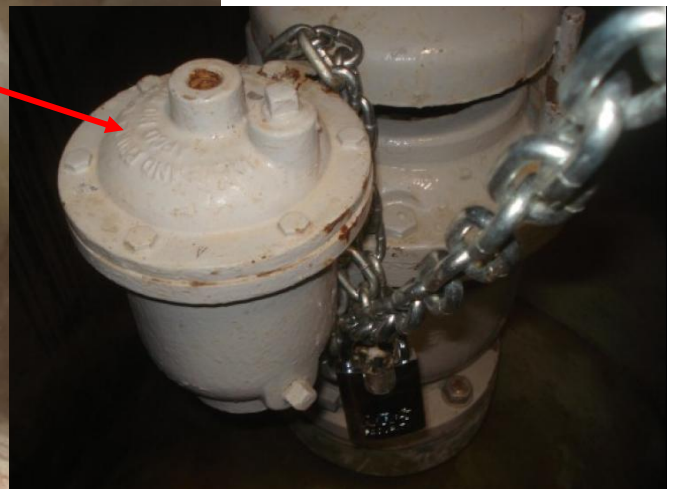
**Site Photo 5. Close up of Site Photo 4**

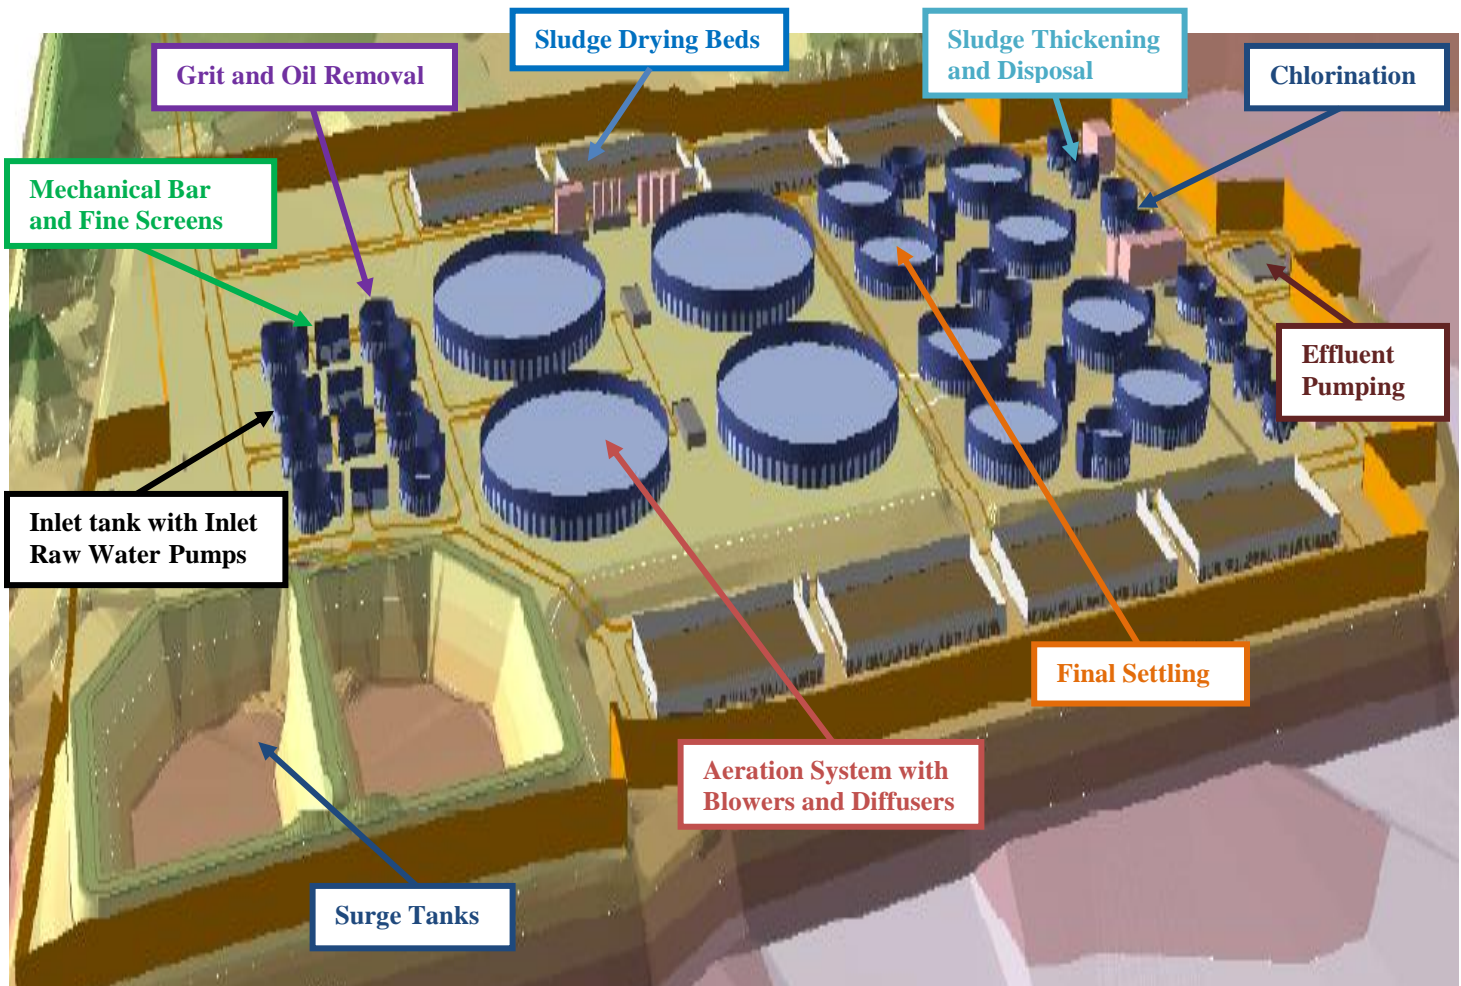
The design later included surge storage basin capacity to the layout, along with a bypass system, to accommodate anticipated influent wastewater flows that exceed the combined ability of the packaged treatment system. Sludge will be thickened and placed on the sludge drying beds, after which it will need to be removed and properly disposed. The treated wastewater will then be discharged directly into the Euphrates River. Figure 6 provides an illustration of the WWTP and its components/processes.

Figure 6. General site arrangement of the WWTP

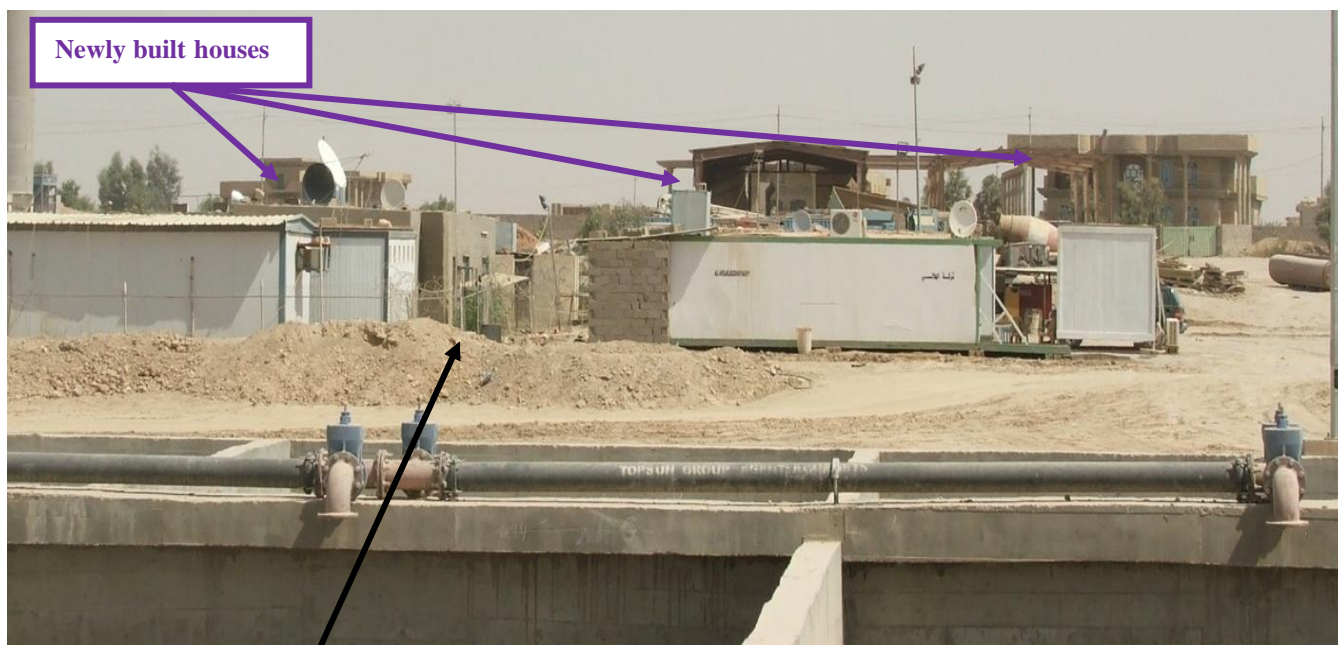
One of the primary reasons the MMPW rejected the use of the original design of a lagoon system was that it would lead to the “arising of stinking odor.” However, the MMPW’s design for the WWTP using the activate sludge units did not provide for odor control. Specifically, there are no odor control facilities furnished with this plant. According to Camp Falluja Resident Office representatives, the surge tank, inlet tank, and inlet works will generate undesirable odors. In addition, the area near the WWTP is fast developing into a residential area (Site Photo 6 and Figure 7), and it is anticipated that there will be complaints from the residents about the odor. Also, these residents may become angry because they are not part of the collection system. Consequently, these residents will see and smell the WWTP, yet will not benefit at all from it. Further, the residents near pump stations F1 and F5 may experience a “big stink” once the plant goes into operation. During the design review process, the lack of odor control facilities was identified; however, the potential solutions to the odor problem at the WWTP and pump stations are expensive, ranging from at least \$1 million to \$8 million. Due to project funding constraints, this was not remedied.

**Site Photo 6. View of new houses near the WWTP sludge drying beds, where a significant odor will occur  
(photo taken from sludge drying beds)**

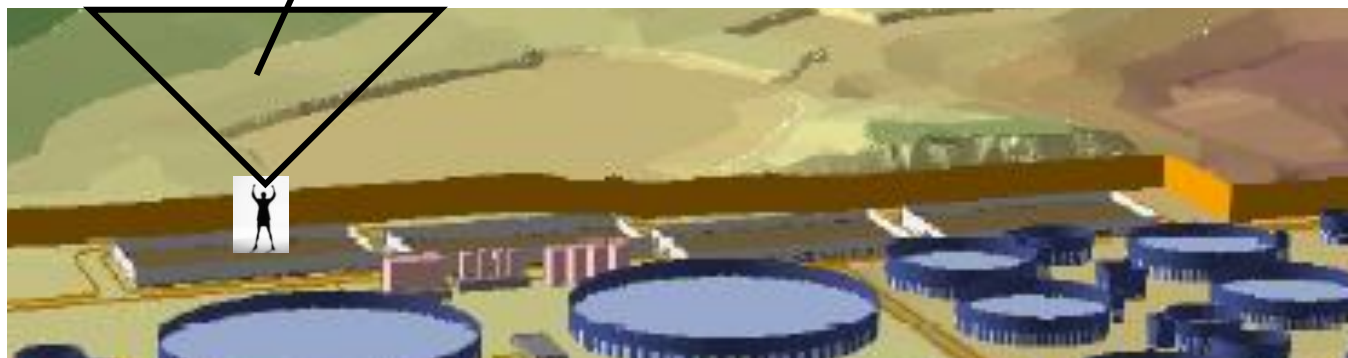
**Figure 7. Portion of the WWTP (sludge drying bed area)**

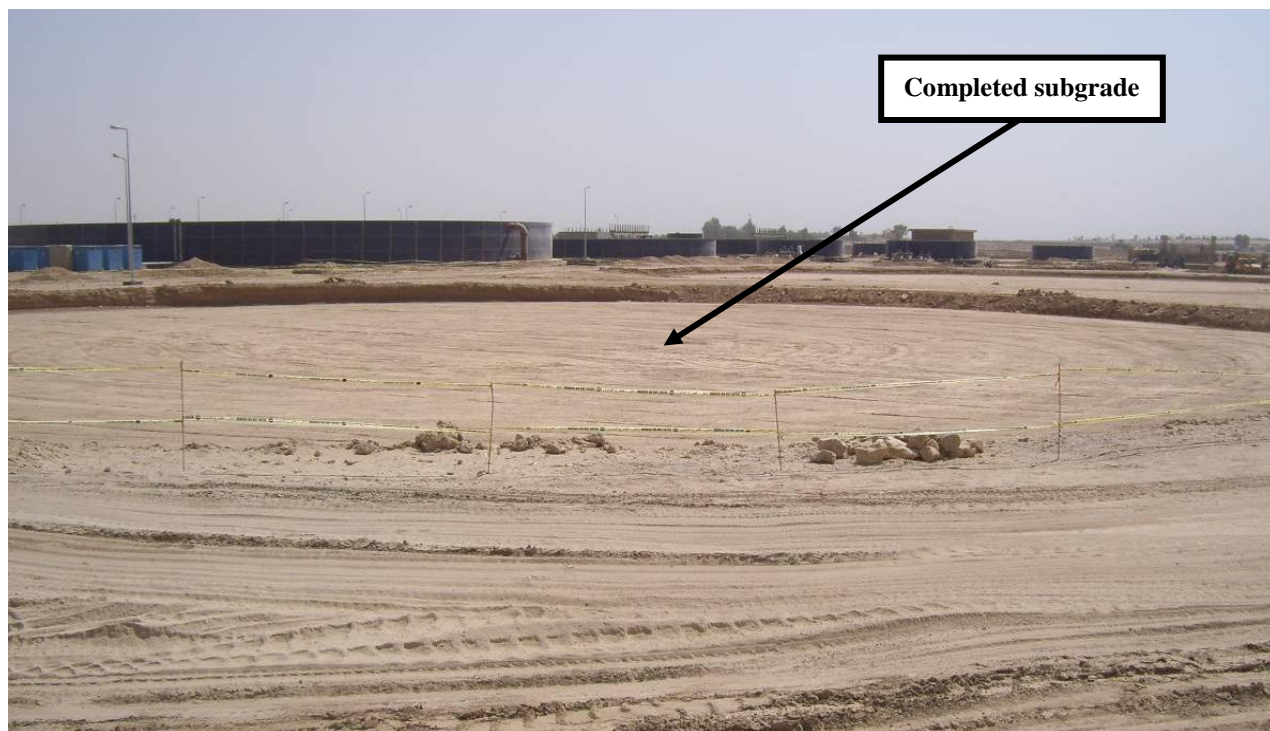
At the time of our site visits, the contractor had completed approximately 70% of the contract. The WWTP appeared to be filled to a consistent elevation of several meters above the adjacent dry lake bed, which should make the facility safe from potential flooding. The earth fill was consistent and appeared to be well compacted. According to Camp Falluja Resident Office representatives, the contractor used a "sheepsfoot" type roller to compact the fill. While the rough grading was complete, the finish grading activities had not yet begun. Site Photo 7 provides an example of the contractor's work, specifically the aeration tank subgrade.

**Site Photo 7. Aeration tank subgrade**

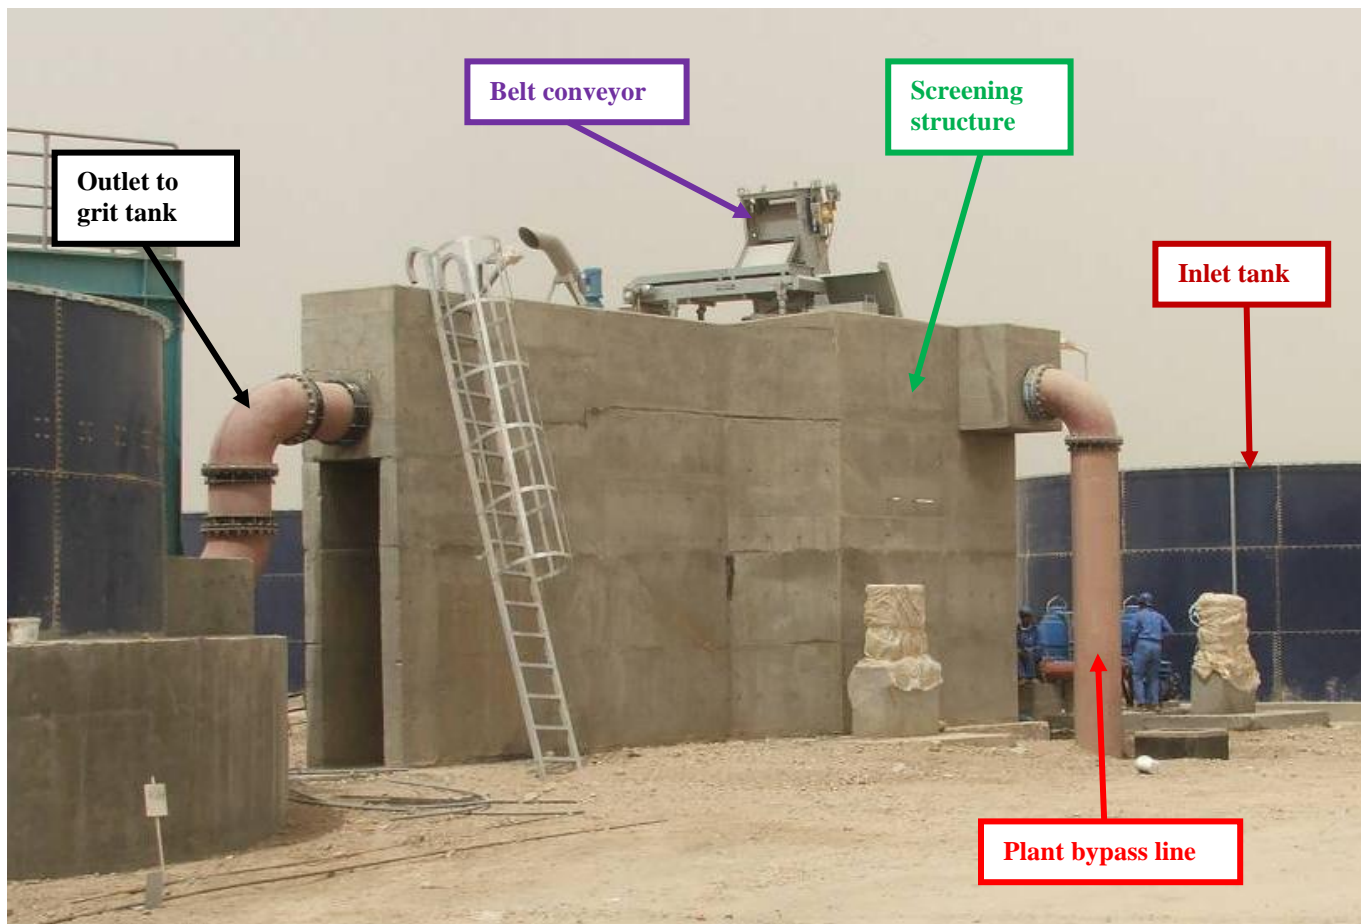
We observed the steel inlet tanks (Site Photo 8) and concrete foundations, which appeared to be constructed appropriately. The inlet screens were installed but could not be inspected. Camp Falluja Resident Office representative stated that hydraulic testing of the installed tanks had been completed.

**Site Photo 8. Inlet tank and screen structure**

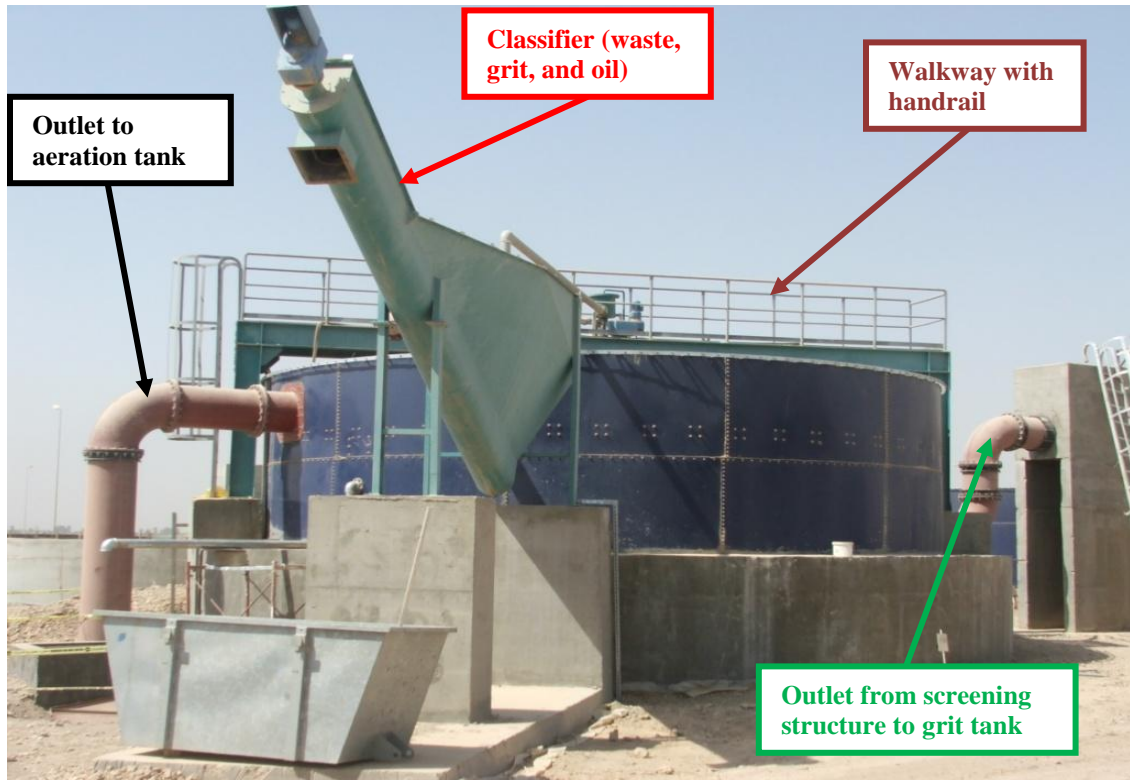
The grit and oil removal steel tanks and concrete foundations appeared to be adequately constructed (Site Photo 9). Camp Falluja Resident Office representative stated that the water stops at the connection between the steel tanks and the concrete foundations had leaked in several areas of the plant. This required the removal of some of the concrete so that the water stop could be repaired. The repairs appeared to be an epoxy-cement and are solid, which should result in satisfactory performance. We observed the top of the several tanks' foundations showing signs of this repair (Site Photo 10).

Site Photo 9. Oil and grit tank and classifier

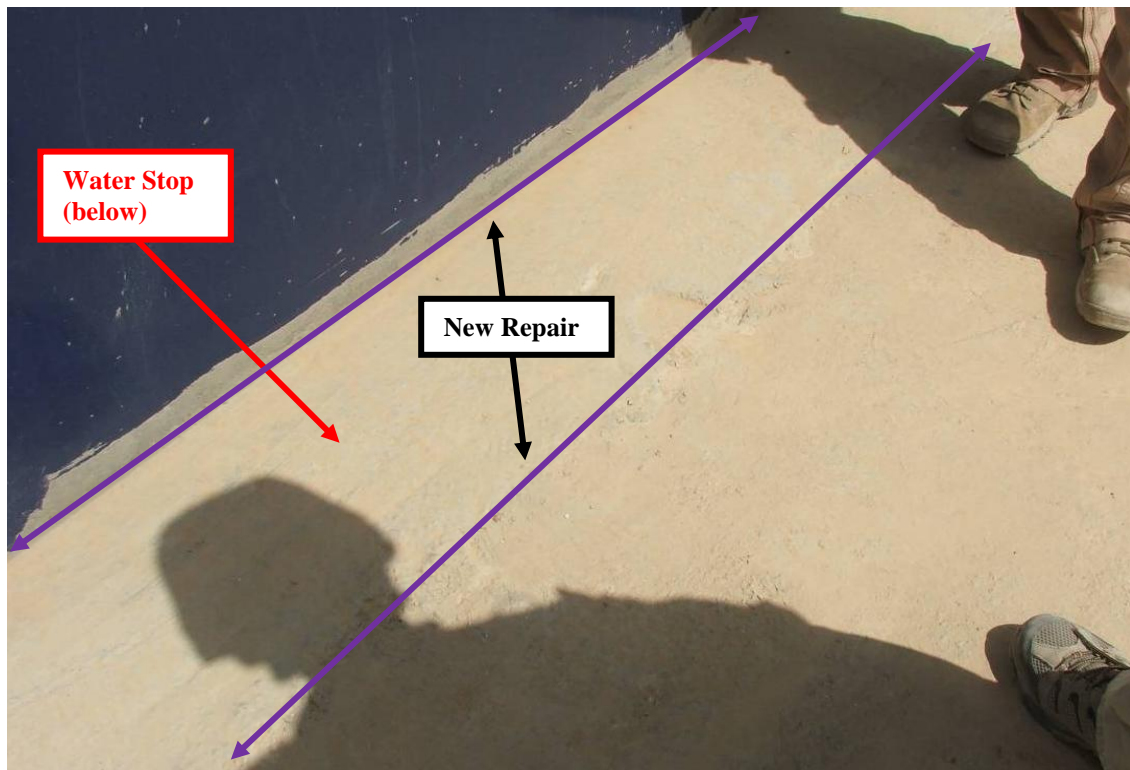
Site Photo 10. Example of concrete repair

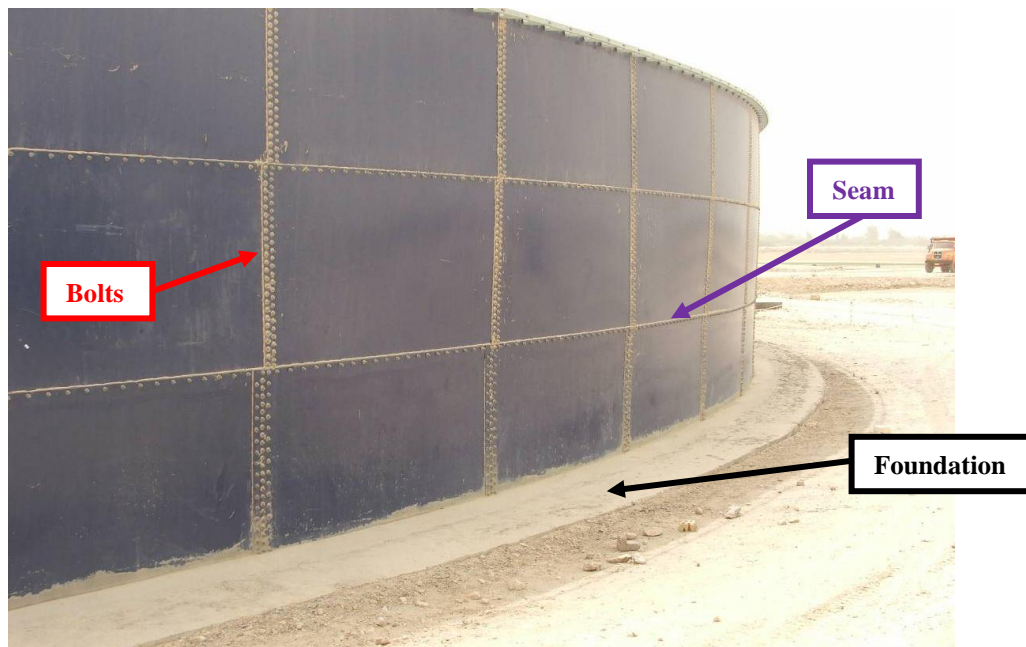
At the time of the site visits, two of the large steel aeration tanks had been installed (Site Photo 11). The tanks are constructed in sections and are bolted together on site. Each bolt and tank seam appeared to have sufficient amounts of sealant, and according to a Camp Falluja Resident Office representative, the hydraulic testing of the tanks has been completed. The Camp Falluja Resident Office representative stated some of the PVC diffusers in the tanks have been exposed to sunlight and will need to be replaced before commissioning. Some PVC materials degrade when exposed to sunlight, but once operational, the materials will be under the surface of the water and will not be exposed to sunlight except for during maintenance periods. The subgrade for two more aeration tanks was compacted and was ready to start constructing the foundations.

Site Photo 11. Aeration tank

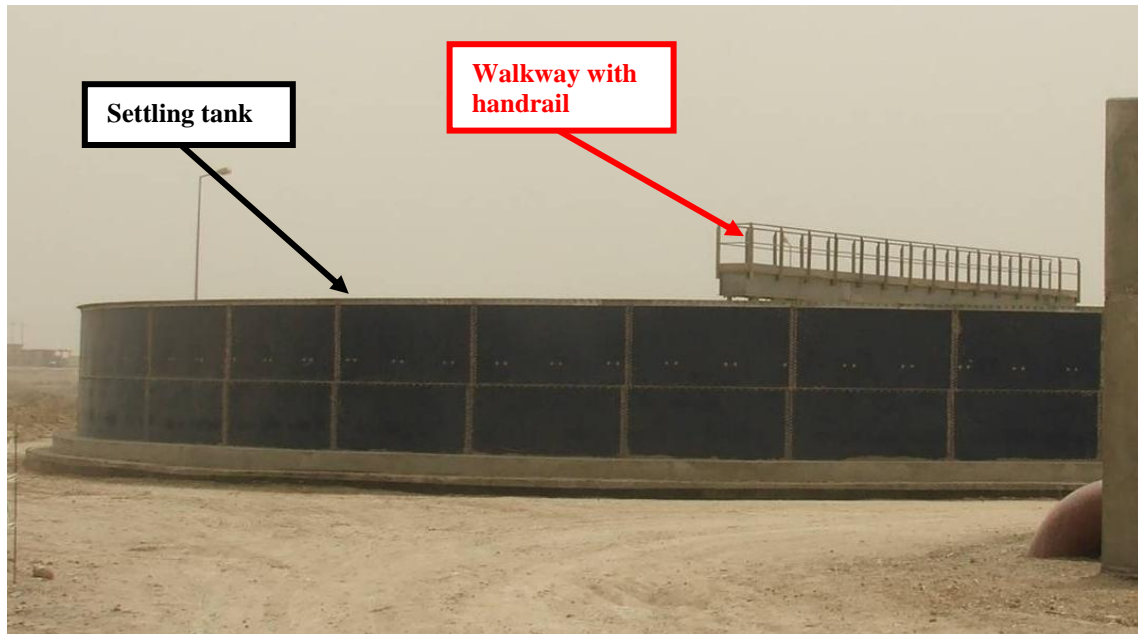
We inspected the final settling tanks for two of the treatment trains (Site Photo 12). The steel tanks, concrete foundations and mechanical equipment appeared to be installed in accordance with the design drawings. Camp Falluja Resident Office representative stated the underground piping and underground electrical wiring has been installed; however, the electrical wiring has not been completed in the Electrical Building.

**Site Photo 12. Settling tank and concrete foundation**

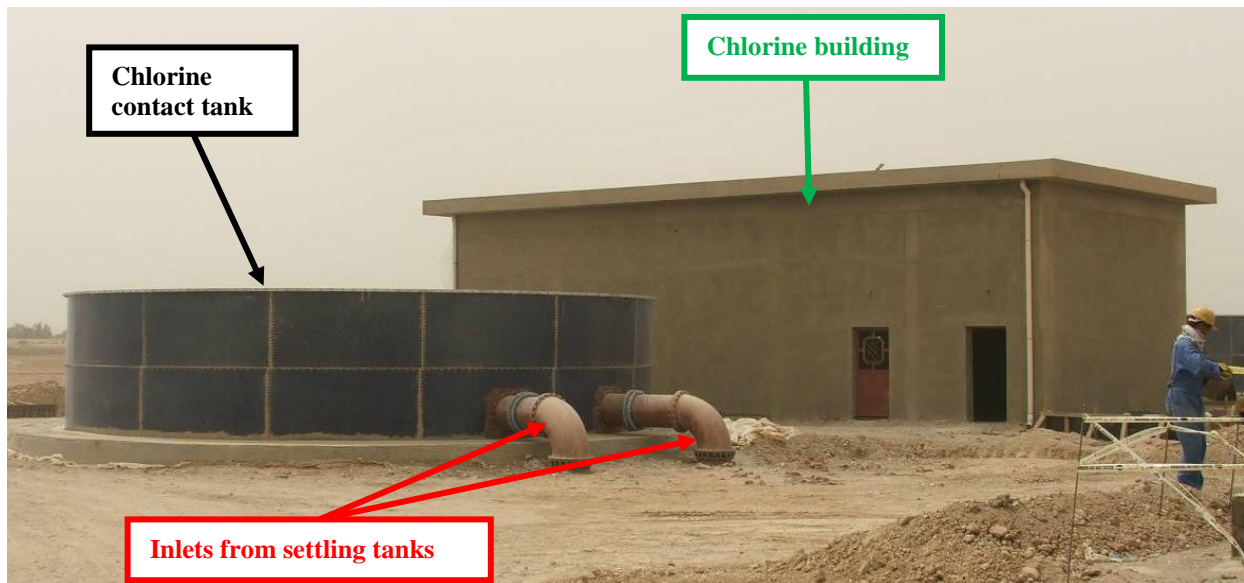
At the time of the site visits, the chlorine contact steel tanks and concrete foundations had been installed for the first two trains (Site Photo 13). The tanks and foundations appeared to be adequately constructed and in accordance with design drawings. The Chemical Building was not complete and no equipment was installed.

**Site Photo 13. Chlorine contact tank and chlorine building**

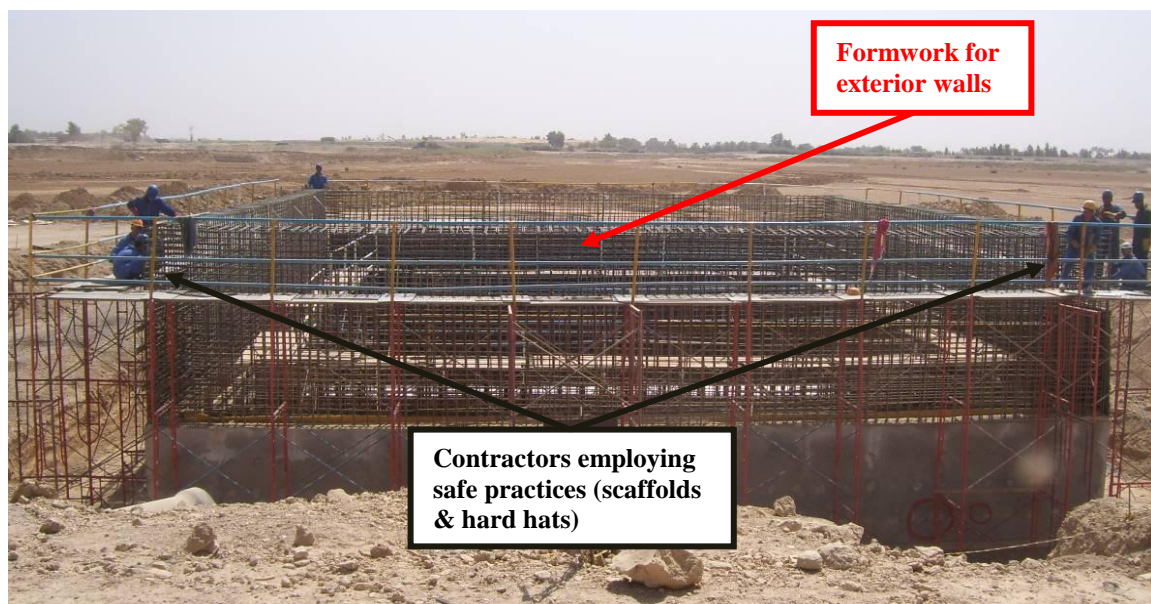
At the time of the site visits, the effluent pump station was partially constructed (Site Photo 14). The reinforced concrete walls were being formed to pour in the near future. The pump installation, piping connections, and backfill around the pump station still need to be completed.

**Site Photo 14. Effluent pump station construction**

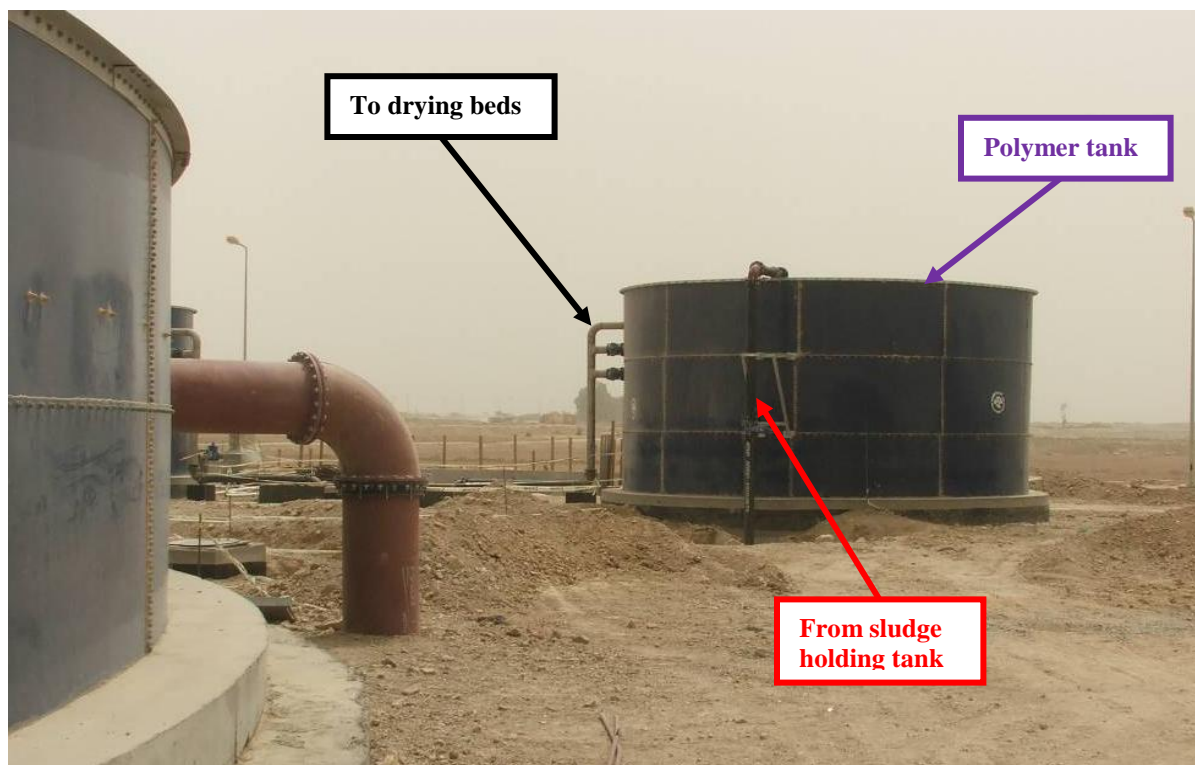
During our site visits, we observed two installed polymer mixing tanks<sup>14</sup>, which appeared to be constructed in accordance with design drawings (Site Photo 15). Camp Falluja Resident Office representative stated that initial commissioning will not use the polymer mixing tanks to its full potential because the gravity belt thickener is not being purchased with this contract; rather the interim process will be to inject the polymer into the sludge and send it to the sludge drying beds. The Camp Falluja Resident Office representative was concerned with using the polymer mixing tanks without having a gravity thickener to process the sludge. The primary concern is that the sludge polymer mixture would become too solid and the pumps would not be able to move the mixture to the drying beds. Pumping solid materials could result the clogging of the pipes and reduce the life of the pumps.

Site Photo 15. Polymer mixing tank

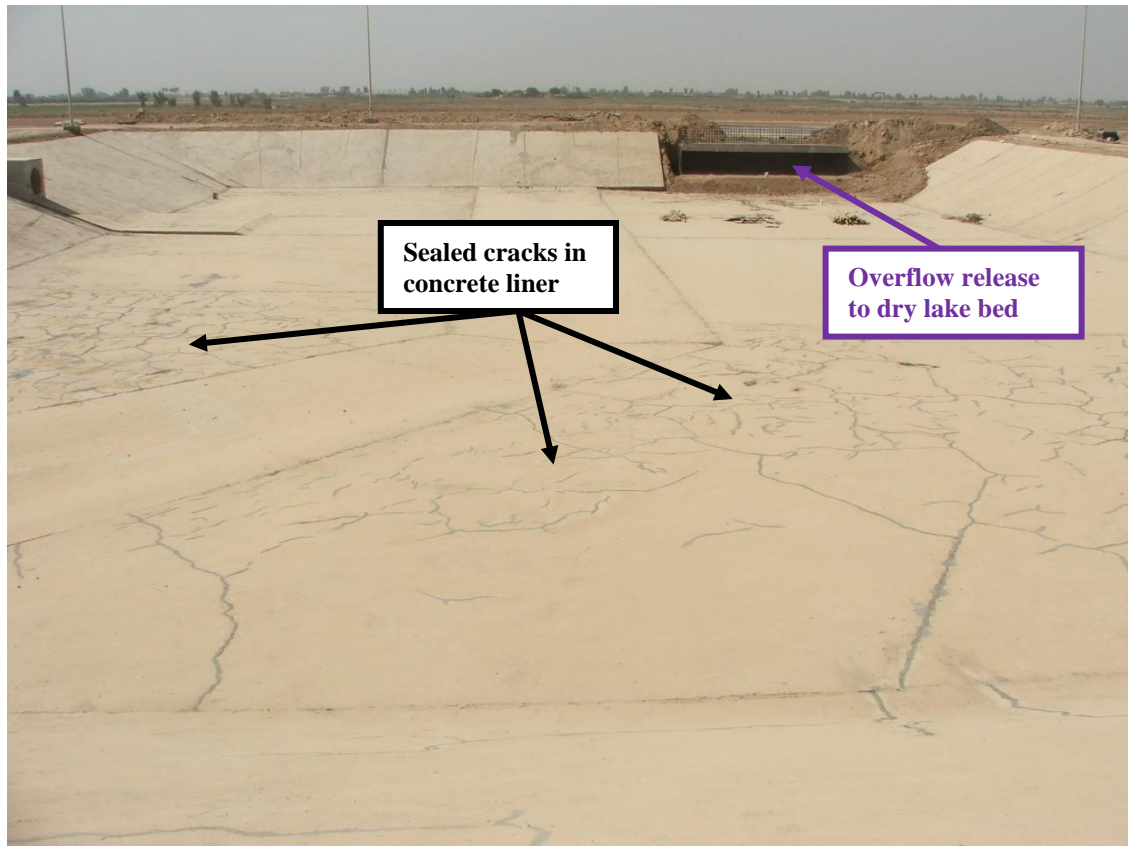
We observed the two constructed surge basins (Site Photo 16). The configuration of the surge basins appeared to match that of the construction specifications. An emergency overflow structure was constructed in the first basin and an equalization pipe was installed in between the two basins. The basins were constructed of earth fill material and were lined with concrete. According to the Camp Falluja Resident Office representative, the contractor requested to use concrete for the liner instead of the specification requirement of a cement/earth mixture. We noticed several cracks in the liner; however, the cracks appeared to be adequately sealed.

**Site Photo 16. Surge basin**

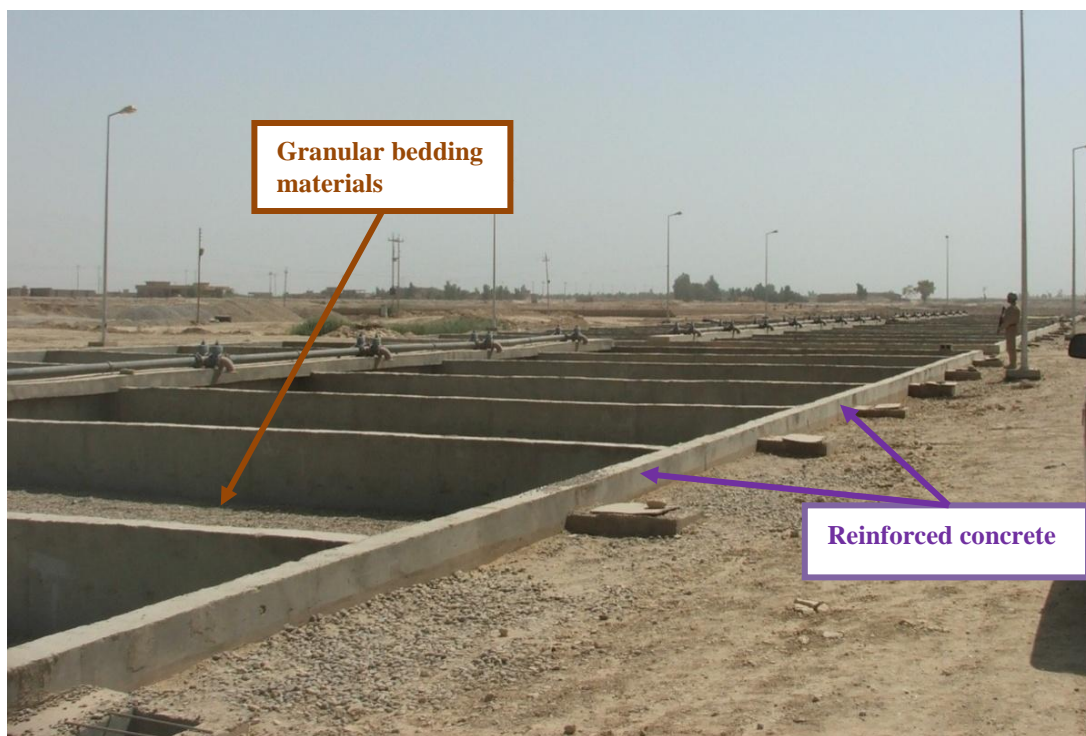
We observed the sludge drying beds (Site Photo 17), which were constructed of reinforced concrete with granular bedding materials installed to filter the sludge/water mixture. The sludge drying beds appeared to be constructed in accordance with design specifications. The water flows through the granular media and is pumped back to the inlet tank. The sludge is trapped on the media and when sufficiently dried is removed and disposed of off-site.

Site Photo 17. Sludge drying beds

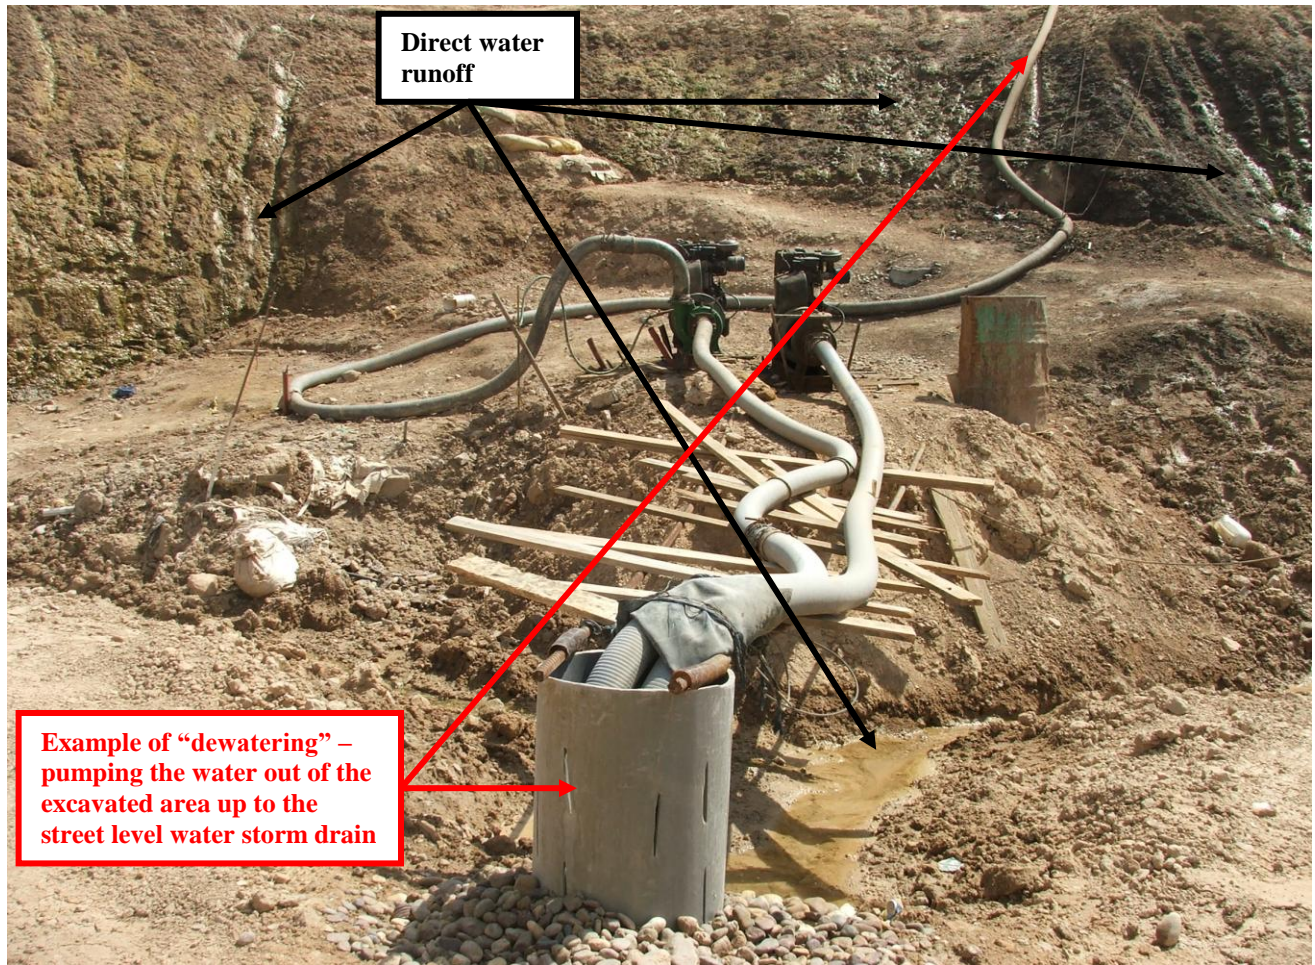
**Site Photo 18. Water runoff and dewatering system**

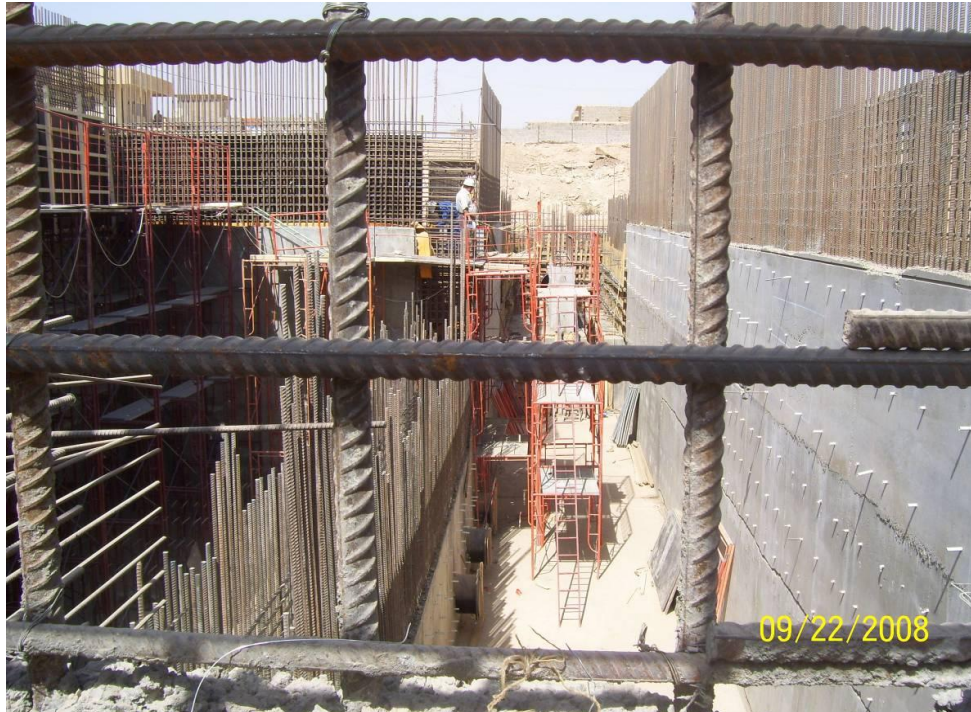
The F1’s reinforced concrete walls were being formed to pour concrete (Site Photo 19). The steel reinforcement had been erected and the walls appeared to be constructed in approximately 2 meter sections. In between each section of the wall construction a water stop gasket was installed. During our site visit, we observed areas of inadequately poured concrete (Site Photos 20 and 21). The Camp Falluja Resident Office representative stated the unacceptable concrete work had previously been identified on a deficiency list from a previous quality assurance (QA) report. The unacceptable areas have been marked and the contractor will remove and replace it. The Camp Falluja Resident Office representative brought the contractor over to the areas in question and reiterated to the contractor that the deficient must be replaced. The contractor agreed to remove and replace the deficient concrete. The pump station floor was constructed of reinforced concrete, which appeared acceptable.

**Site Photo 19. Pump Station F1 wall construction**

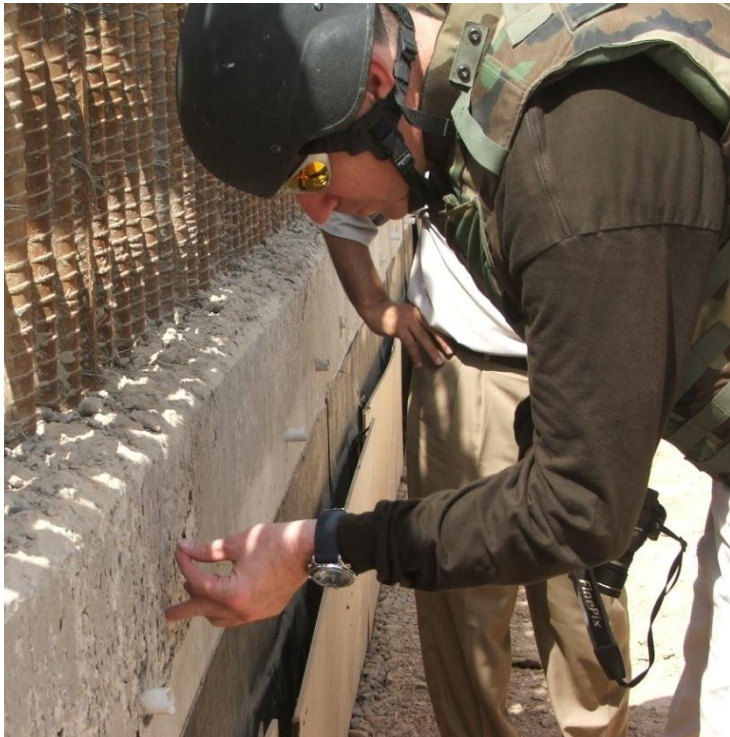
**Site Photo 20. SIGIR Inspector checking concrete work**
